Home Inspection Report

1300 Sydney St., Ocean Springs , MS 39564

Friday October 13, 2017

8603728

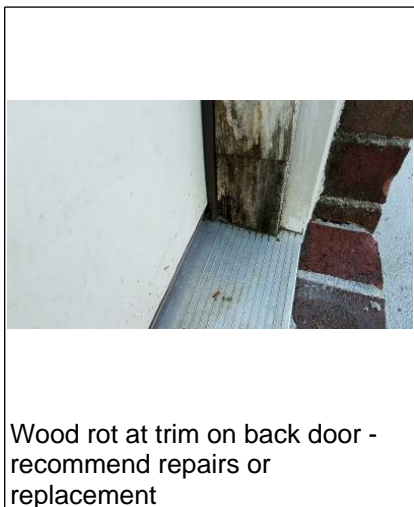
Comments Rotted trim board at rear door - recommend repair/replacing damaged sections

Wood rot at trim on back door - recommend repairs or replacement

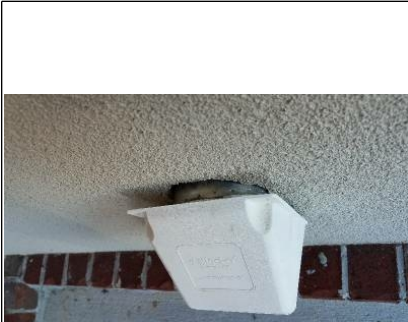
Dryer vent cap on exterior wall needs to be secured to the wall and sealed around the edges - recommend repairs

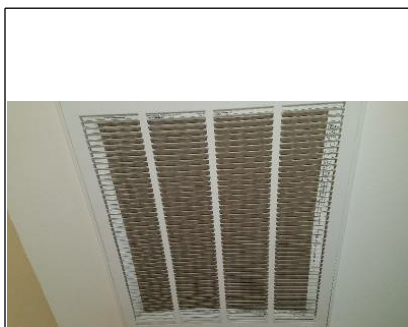
Air filter is dirty - recommend replacing
