Home Inspection Report

1300 Sydney St., Ocean Springs , MS 39564

Friday October 13, 2017

8603728

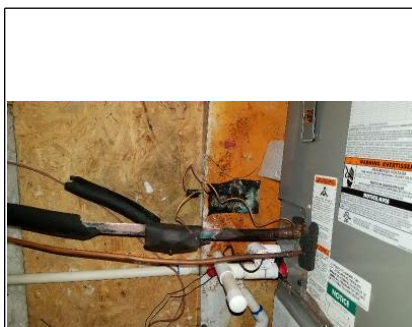
Insulation damaged/missing around heat pump suction line at air handler - recommend repairs or replacement
