Home Inspection Report

2300 Tradewinds Dr, Gautier , MS 39553

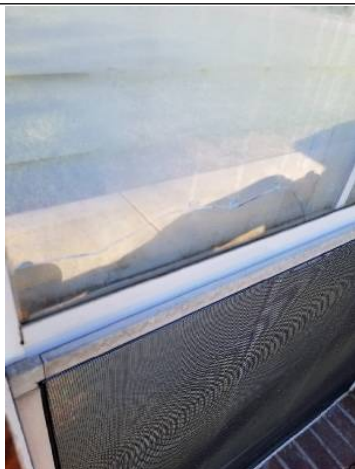
Cracked window noted at front side of home during time of inspection - recommend repairs or replacement

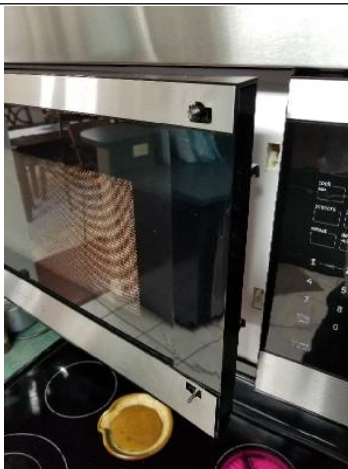
Damaged/missing handle noted at microwave in kitchen - recommend repairs or replacement

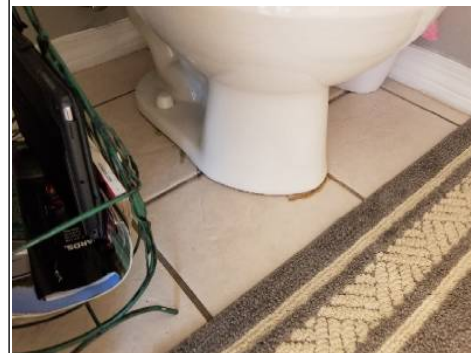
Toilet bowl loose in master bathroom during time of inspection - recommend securing to floor and caulking around the base

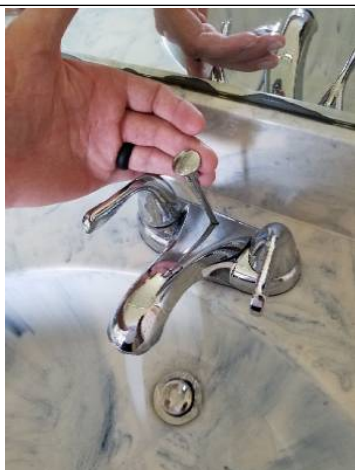
Drain stop in master bathroom not operating properly during time of inspection - recommend repairs or replacement

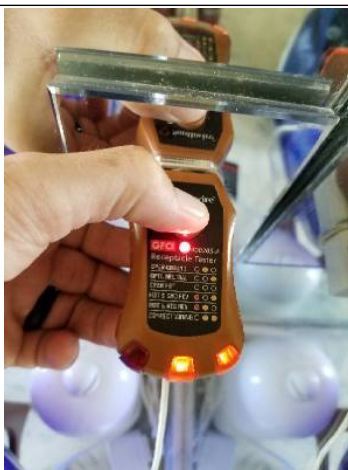
All outlets located in bathrooms should be GFCI protected - recommend upgrading outlets for GFCI protection

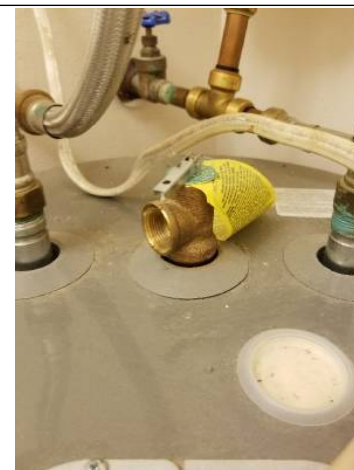
Water heater missing TPR valve discharge pipe - Temperature-Pressure Relief valve extension pipe should extend to within 4"-6" off of the floor - this is a Safety Concern - recommend repairs

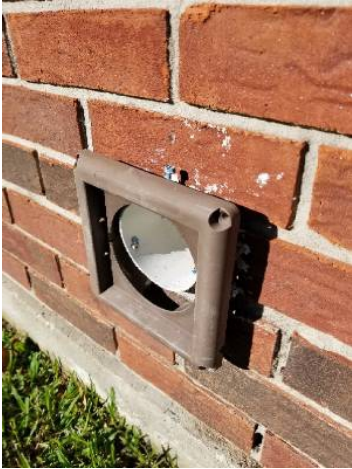
Laundry dryer vent cover at exterior wall damaged/missing - recommend repairs or replacement
